DOE/NV--1170

Amchitka Mud Pit Sites 2006 Post-Closure Monitoring and Inspection Report Amchitka Island, Alaska

September 2006

Prepared by Stoller-Navarro Joint Venture

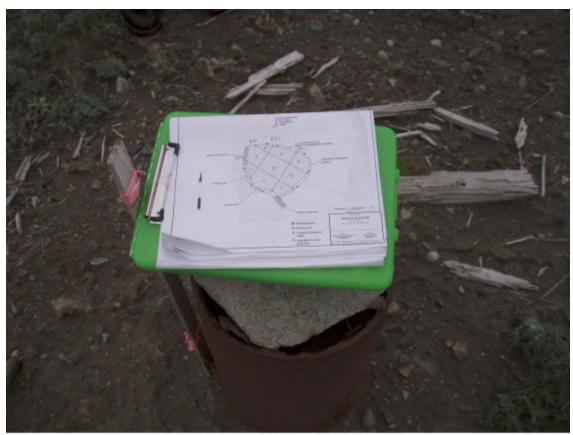
2.	Security markers; signs		11	Tions Detected				
	a. Displacement of site markers, boundary markers, or monuments?		X	USFWS Monument was present / Good Condition

P8040031 Rifle Range USFWS Monument

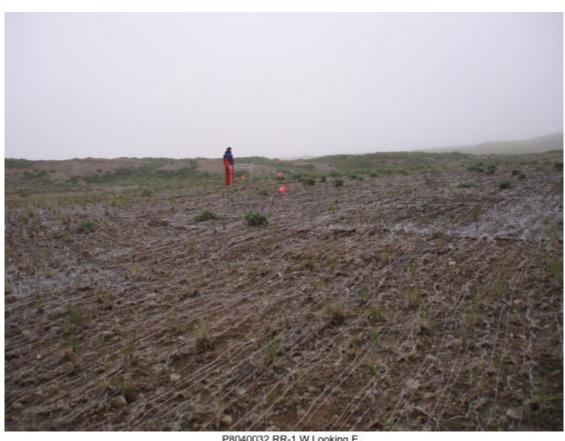
P8040032 RR-1 W Looking E

Cap RR is located approximately three miles northwest of Constantine Harbor with an elevation of 54 to 59 feet. The cap is located in the Crowberry Meadow Community of Amundsen (1972). Vegetation cover on this cap (30.5 % cover) was approximately four times the levels found at Cap F. The cover of species other than *F. rubra* and *D. behringensis* is consistent with the elevation trend observed among the caps (Figure 2.1). Species diversity also was consistent with the elevation with a total of 14 taxa observed (Figure 2.2). This is the largest number of taxa observed at any cap. The abundance of *F. rubra* and *D. behringensis* (8.8 % cover) also is consistent with the expected value for the elevation of the cap.

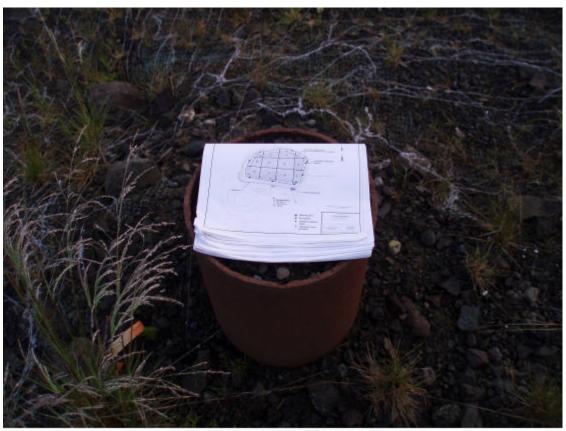
P8050034 Longshot USFWS Monument

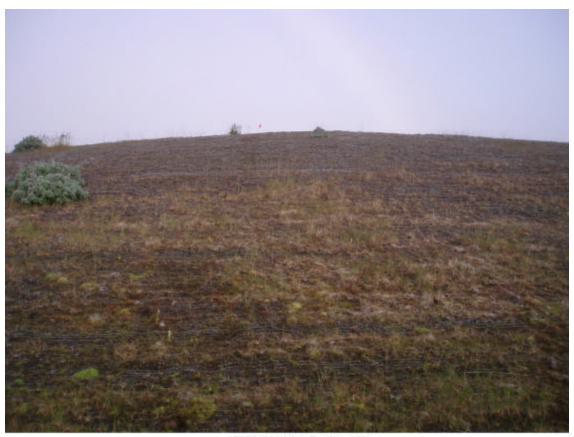
P8050036 LS-1 E Looking W

Cap LS is located approximately four and a half miles northwest of Constantine Harbor with an elevation of 140 to 165 feet. The cap is located in the Crowberry Meadow Community of Amundsen (1972), and vegetation cover on this cap (49 % cover) was approximately six times the levels found at Cap F as would be expected from the low elevation of this site (Figure 2.1). *F. rubra* and *D. behringensis* covers 17 % of the cover and represents 34% of the vegetation cover. Species diversity is high on the cap with 13 separate taxa as would be expected from the low elevation of the site (Figure 2.2).

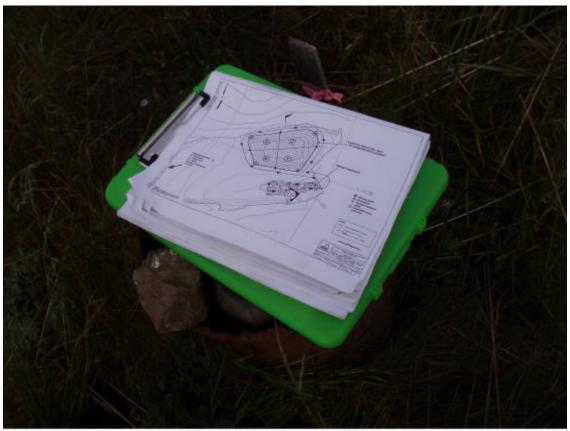
P8040016 CNS USFWS Monument

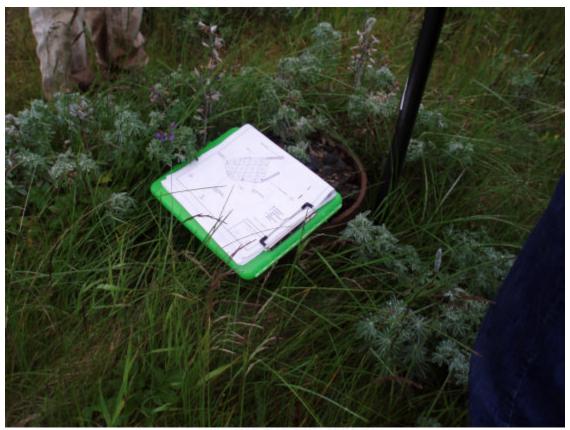
P8040002 CGZ USFWS Monument

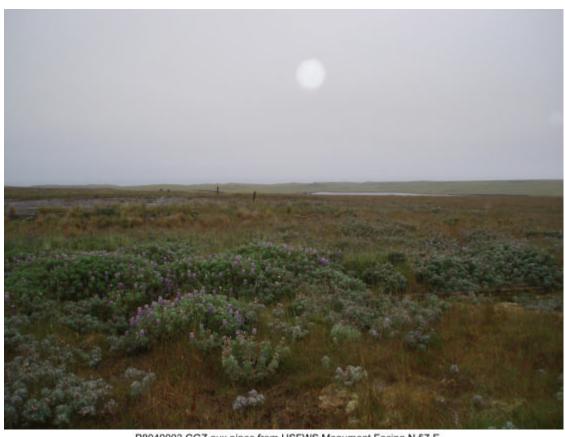
P8040003 CGZ aux pipes from USFWS Monument Facing N 57 E

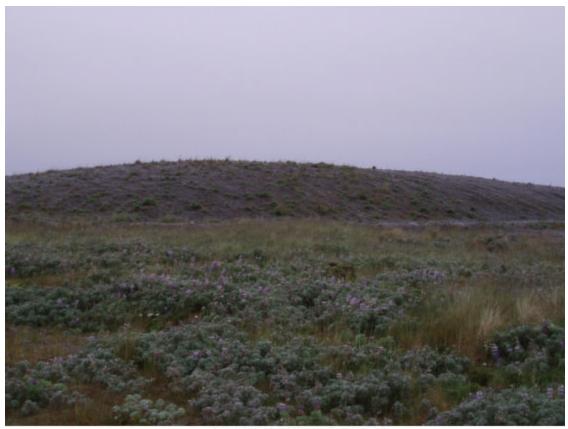
P8040004 CGZ from USGS Monument

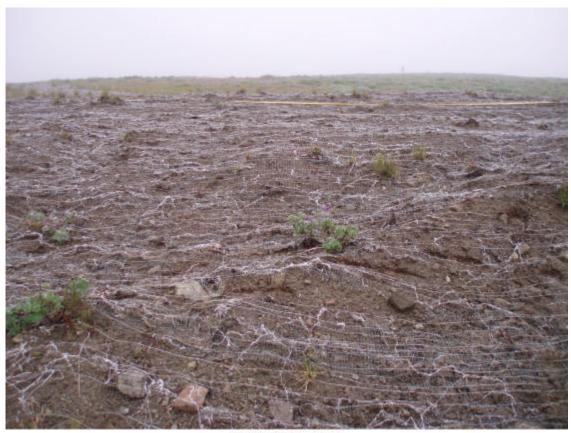
P8020012 Minor Subsidence Transect Area 5

Date	Photo #	GPS Location	Direction of Photo	DESCRIPTION
8/2/06	P8020007	See Figure	N/A	USFWS Monument
8/2/06	P8020008	See Figure	West	Transect F-1 E
8/2/06	P8020009	See Figure	South	North Photopoint looking South
8/2/06	P8020010	See Figure	East	Transect F-1 W
8/2/06	P8020011	See Figure	North	South Photopoint Looking North
8/2/06	P8020012	See Figure	North	Minor subsidence in Grid Area 5
			_	
			_	
	_

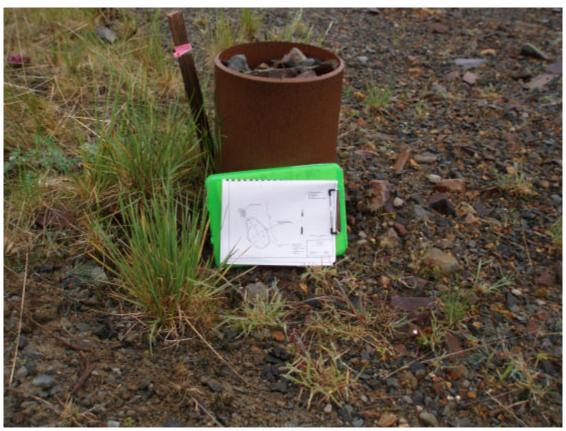
P8020001 Drill Site E USFWS Monument

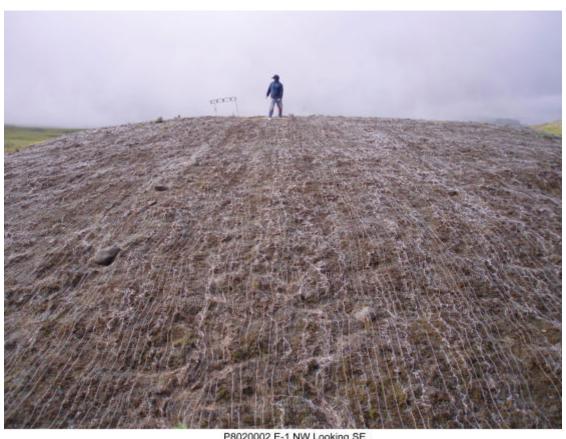
P8020002 E-1 NW Looking SE

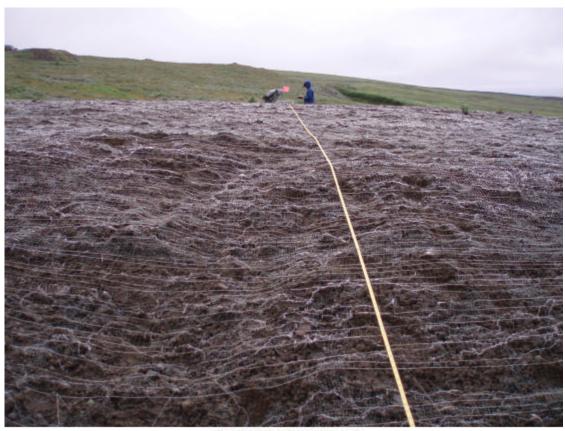
P8020003 E-2 SW Looking NE

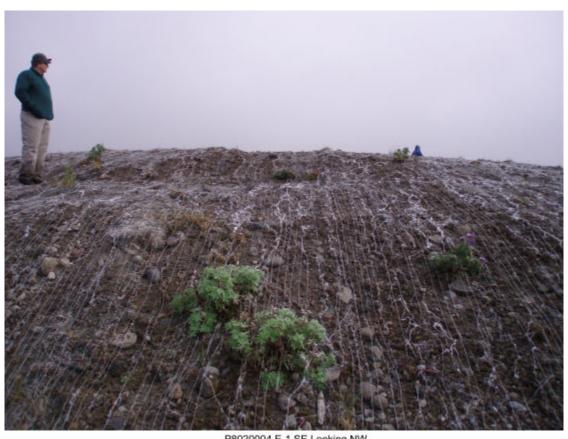
P8020004 E-1 SE Looking NW

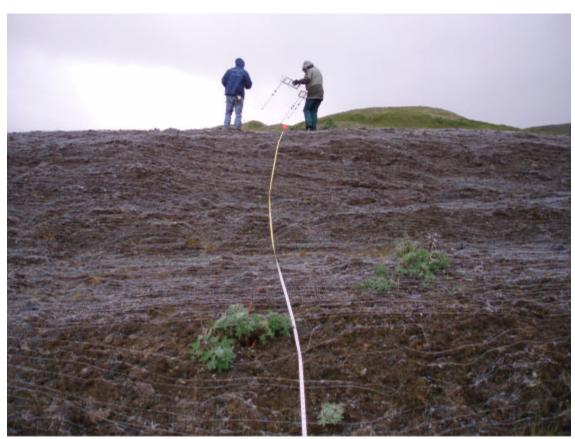
P8020005 E-2 NE Looking SW
